# Manhole Inspection Summary

Manhole # S01I2005MH

**Inspection** ☐ Is Incomplete Rating: **3) Fair**

**Location** Address: **Elray Dr**

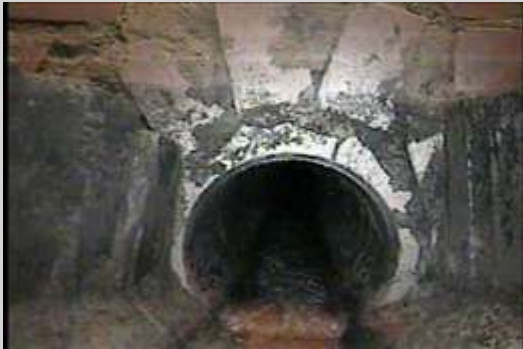
### 6 in. Circular Gravity Sewer Pipe Out @ 12 O'Clock

Pipe Material: **Clay** ☐ Pipe Lined

Invert Depth: **7.34** (ft.) Flow Characteristics: **Slow**

Infiltration: **None** Pipe Seal Cond: **Sound**

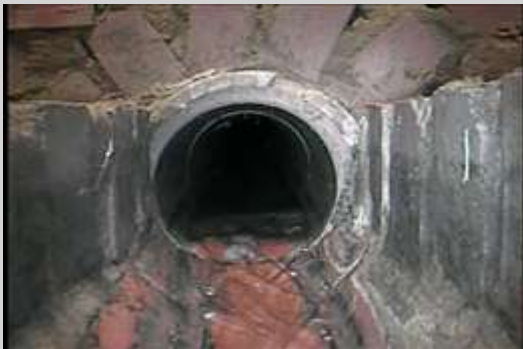
### 6 in. Circular Gravity Sewer Pipe In @ 4 O'Clock

Pipe Material: **Clay** ☐ Pipe Lined

Invert Depth: **7.05** (ft.) Flow Characteristics: **Slow**

Infiltration: **None** Pipe Seal Cond: **Cracked**
